## ZINCOR SYSTEMS

## CASE STUDY 01

# Coating delamination from a machined metal surface

Photographic analysis of adhesive failure on a milled/turned substrate

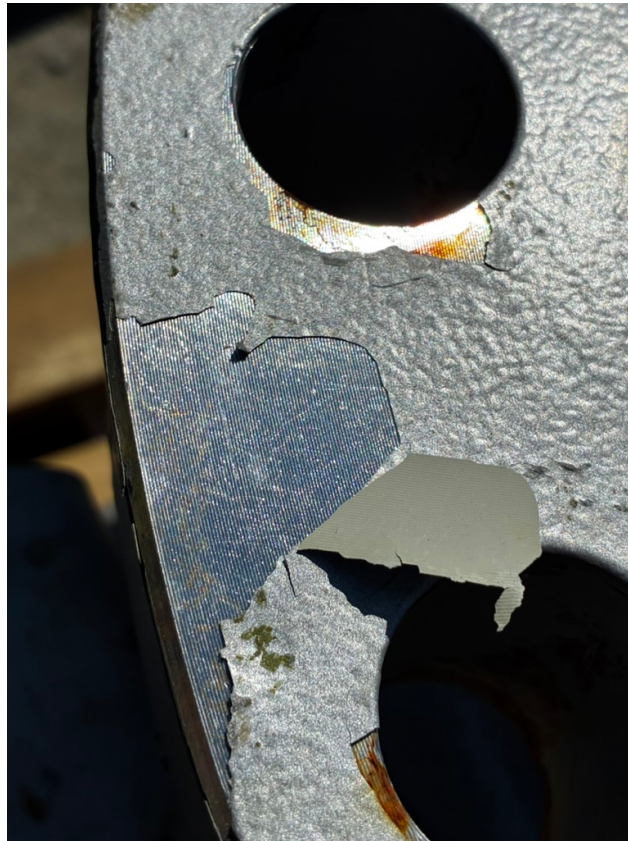
Figure 1. Extensive coating separation from a machined metal surface. Milling/turning marks and locally exposed base metal are visible.

**Key finding:** Adhesive failure at the metal/coating interface, most likely caused by inadequate preparation of the machined surface and possible contamination by machining fluid.

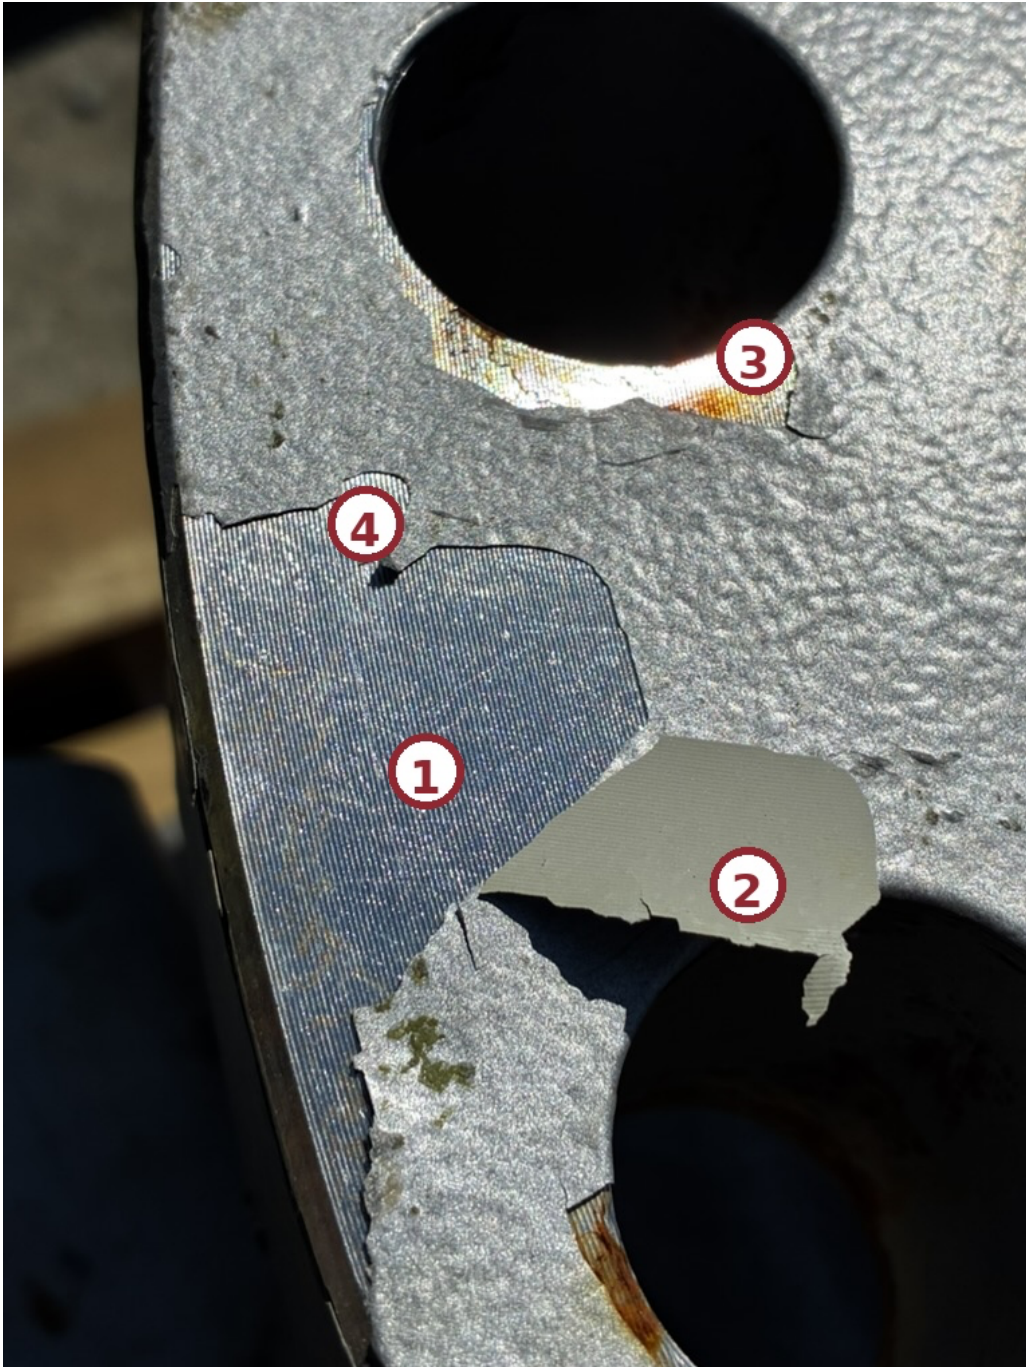
Figure 2. Numbered zones used for the analysis. The labels were deliberately applied without text boxes so that surface details remain visible.

**1 - exposed machined surface:** Parallel machining lines remain visible on the substrate. Almost no cohesive primer residue is present, indicating that failure propagated directly along the metal-coating interface.

**2 - detached coating sheet:** The film remains relatively intact and flexible. Its cohesive strength is greater than its adhesive strength to the substrate.

**3 - local corrosion near the opening:** Brown discoloration occurs along edges and damaged areas. It is probably a secondary consequence of base-metal exposure after local loss of protection, not the primary cause of widespread peeling.

**4 - directional milling or turning marks:** This topography may look rough, yet it can still provide a low effective profile in the direction of separation and limited area for three-dimensional coating anchorage.
